Cerclage Breakage in Trochanteric Revision – High Risk for Hip Endoprosthesis?

M. J. KRAUS, A. M. NOWAKOWSKI

Department of Orthopaedic and Trauma Surgery, University Hospital Basel, Switzerland

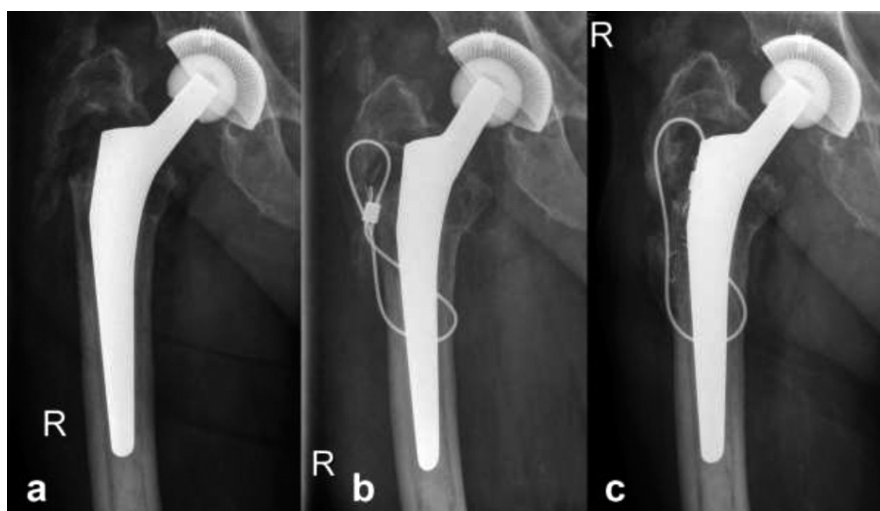
Clinical examination did not reveal a shortening or mal-rotation of the right leg and further clinical examination was limited due to pain in the region of the greater trochanter. A slightly displaced fracture of the greater trochanter (Vancouver A1) was apparent on X-rays and therefore we initially agreed on a conservative treatment. However, osteosynthesis with a multifilament cerclage system (Dall Miles) was performed in January 2011 (Fig. 1b) since persistent pain and delayed union was present under the conservative attempt (Fig. 1a).

Nonetheless, pain was persistent even 23 months after surgical management but cerclage breakage was evident for the first time on X-rays (Fig. 1c) whereas a CT-scan 7 months earlier was negative for any failure.

Fig. 1. Fractured greater trochanter without loosening of the stem seven weeks preoperatively (a). Five days after osteosynthesis (b). 23 month after ORIF cerclage breakage is apparent with non-union of the greater trochanter (c).

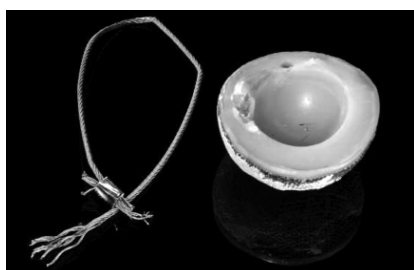
A revision surgery of the hip was performed by the senior author (AMN) in January 2013 with removal of the destructed cerclage and the acetabular cup (Fig. 2).

Fig. 2. Removed broken cerclage cable and cup.

The acetabular cup required a replacement by an acetabular revision ring due to a central acetabular defect. The residual greater trochanter shell was augmented with allograft (cancellous chips and demineralized bone matrix) after careful debridement. Fixation was performed by applying two multifilament cables and K-wires without the use of screws or grip plates in order to prevent damage of the fragile trochanteric fragments (Fig. 5a).

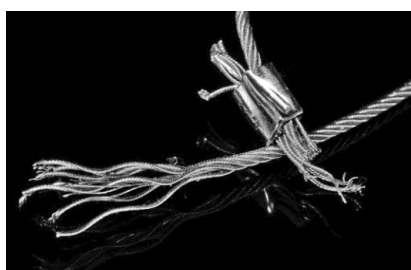
Noteworthy, the cerclage failure was not present adjacent to the clamp or opposite to the cutting site of the parallel cable (Fig. 3). In addition, cerclage fragments were found within the PE-surface inside the cup (Fig. 4) with several scratches on the bearing surface.

Fig. 3. Close-up of the broken multifilament cable.

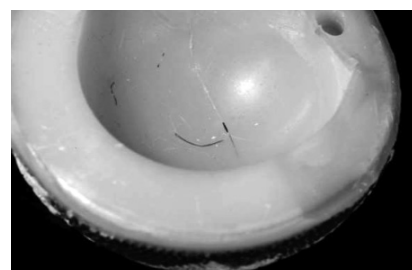
Fig. 4. Close-up of the PE-liner with cable fragments on the surface and within the PE.

We advise the removal of the cables with local debridement regardless of union or non-union of osteotomy- or fracture-sites and the investigation of bearing surfaces whenever a cerclage failure occurs. Hence, cerclage-fragment migration and consecutive catastrophic wear could be prevented.

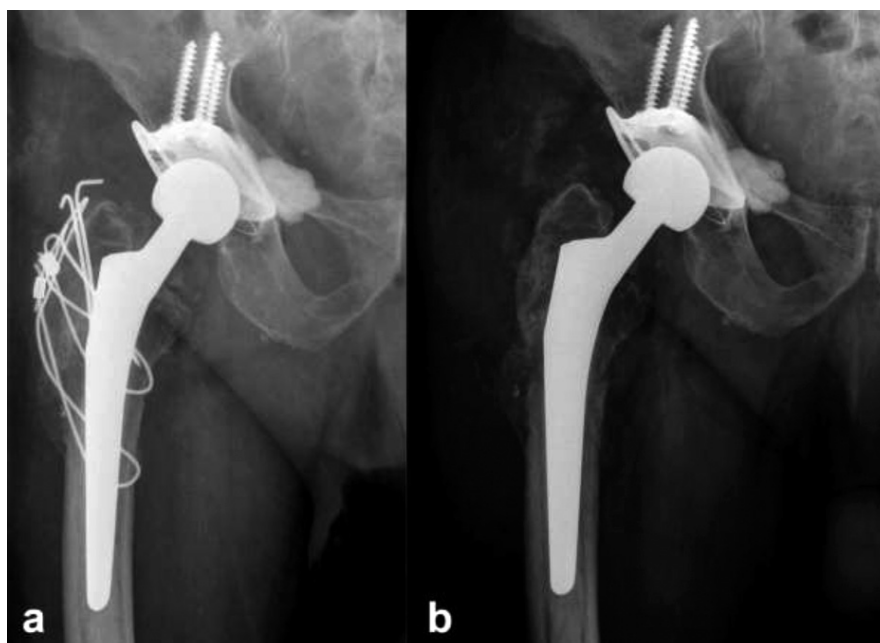
Bone consolidation was evident on follow up X-rays and was confirmed during the metal removal operation 1 year later (Fig. 5b). In August 2014 the patient complained of occasional peritrochanteric pain without requiring pain killers on a regular basis. The patient was perfectly satisfied since he was able to walk for 30 minutes without crutches and no signs of hip abductors insufficiency.

Fig. 5. Postoperative after change of cup and re-ORIF (a). X-ray control 1 year post-operative with removed cerclage and consolidated pseudarthrosis (b).
